Project Name: Anaconda Aluminum Company		Site Location: Columbia Falls Aluminum Company Site, Flathead County, Montana	TDD No: 0004/1305-04
Photo No. 1	Date: 6/3/2013

PHOTOGRAPH LOG

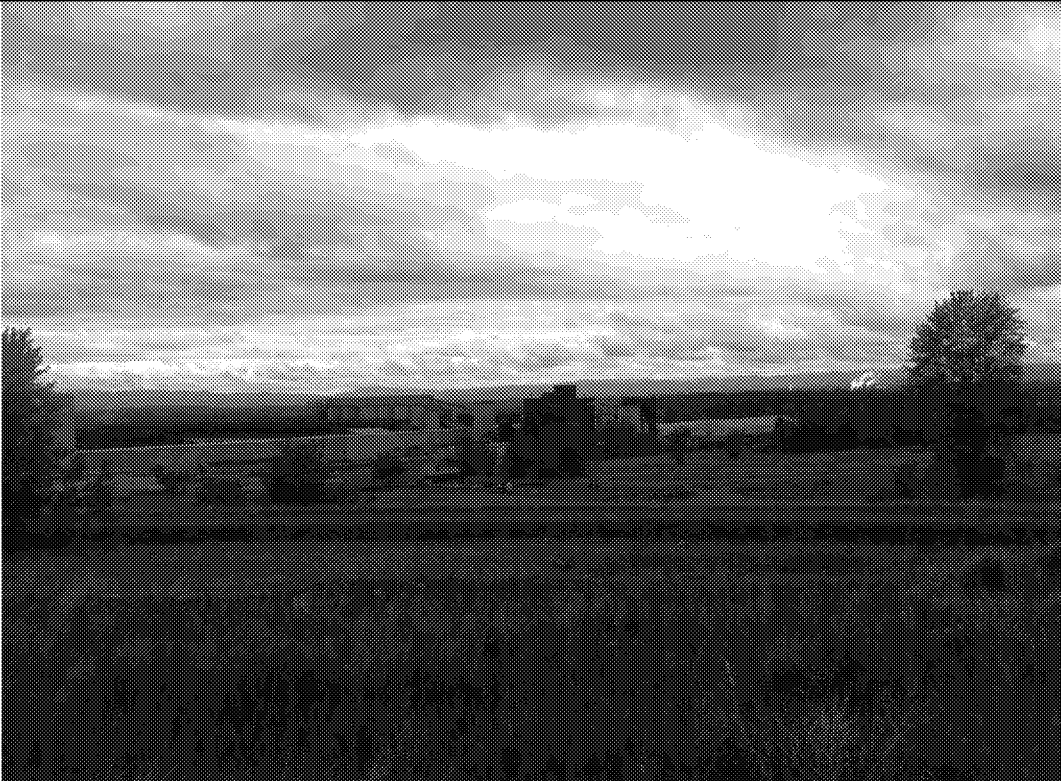
Direction Photo Taken: SE			
Description: Anaconda Aluminum property overview.

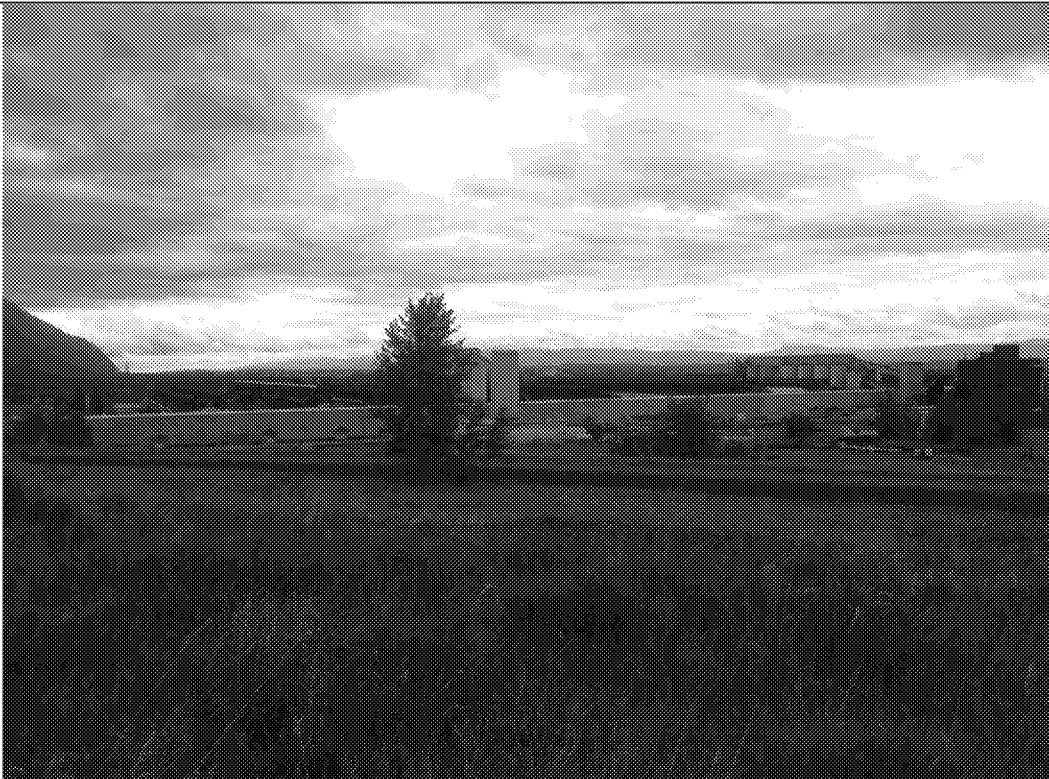
Photo No. 2	Date: 6/3/2013

Direction Photo Taken: SSE		
Description: Anaconda Aluminum property overview.

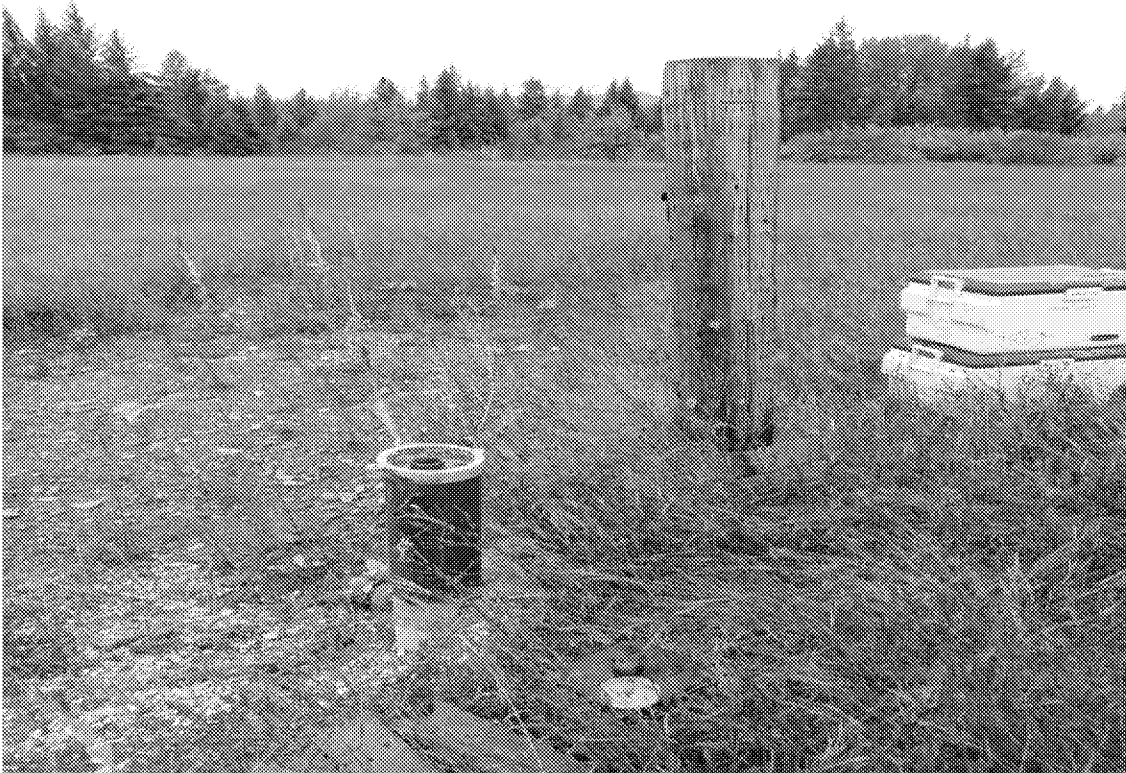
Project Name: Anaconda Aluminum Company		Site Location: Columbia Falls Aluminum Company Site, Flathead County, Montana	TDD No: 0004/1305-04
Photo No. 3	Date: 9/24/2013

Direction Photo Taken: NW			
Description: Showing location for groundwater sample: CF-GW-MW-01.

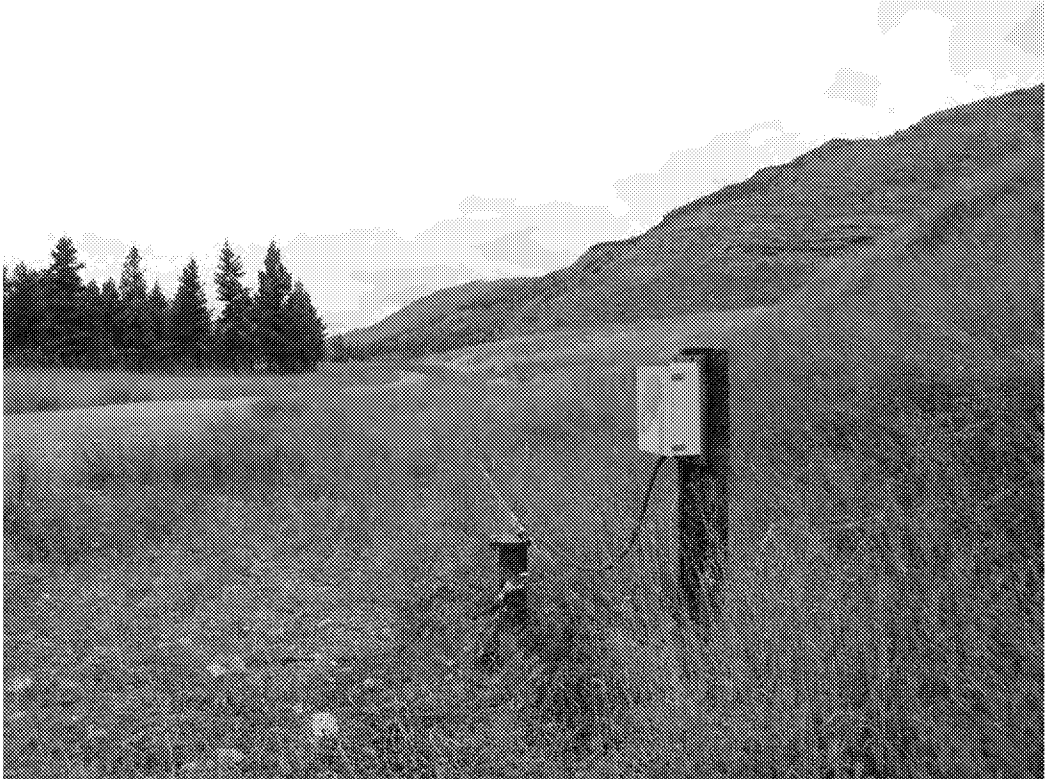
Project Name: Anaconda Aluminum Company		Site Location: Columbia Falls Aluminum Company Site, Flathead County, Montana	TDD No: 0004/1305-04
Photo No. 5	Date: 9/24/2013

Direction Photo Taken: N			
Description: Showing location for groundwater sample: CF-GW-MW-03. Old Wet Scrubber Sludge Pond (E) in background.

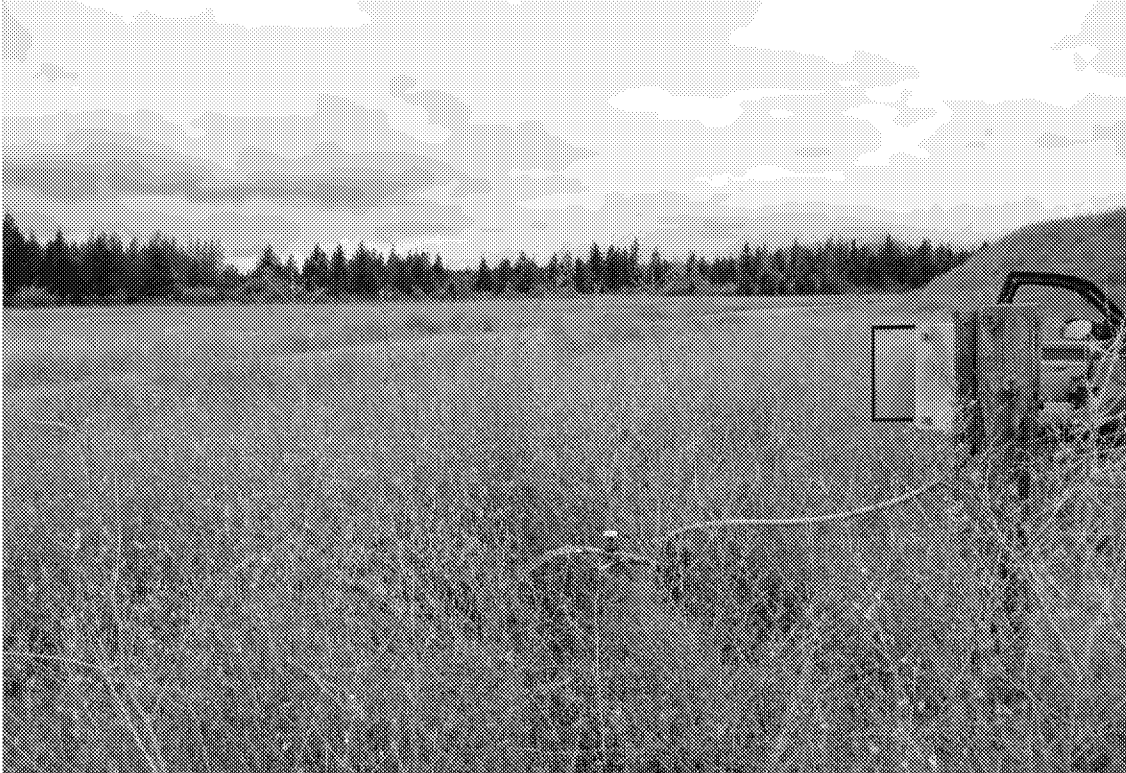
Project Name: Anaconda Aluminum Company		Site Location: Columbia Falls Aluminum Company Site, Flathead County, Montana	TDD No: 0004/1305-04
Photo No. 7	Date: 9/24/2013

Direction Photo Taken: NW			
Description: Showing location for groundwater sample: CF-GW-MW-05. Old Wet Scrubber Sludge Pond (NE) in background.

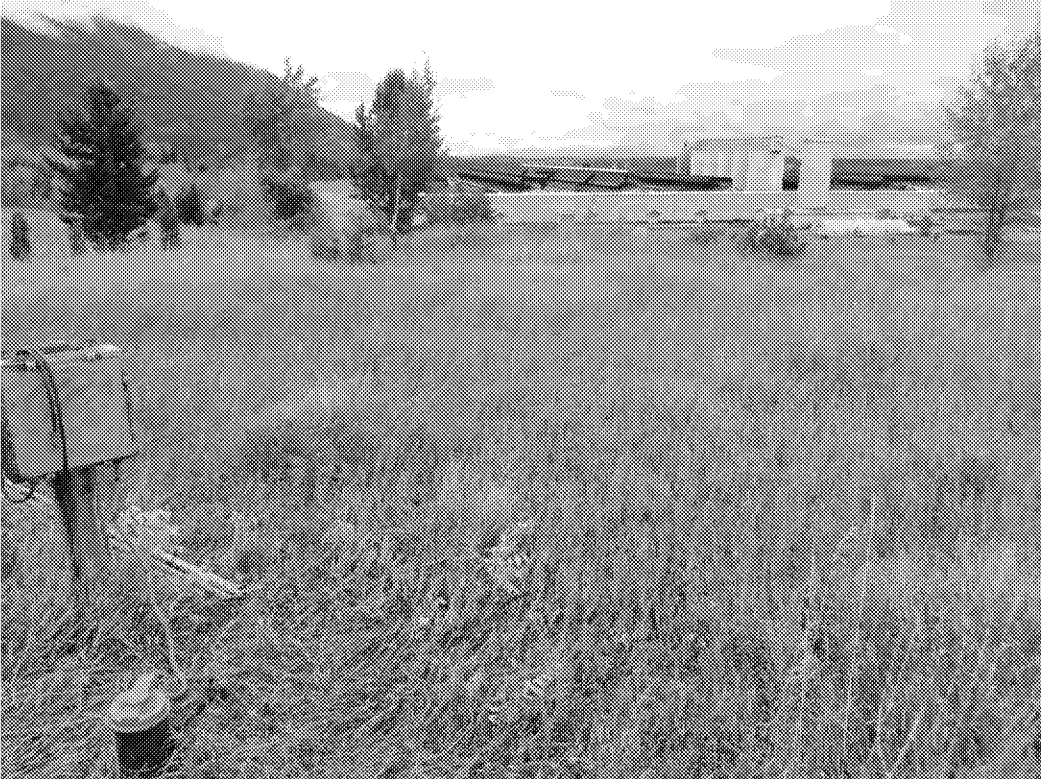
Project Name: Anaconda Aluminum Company		Site Location: Columbia Falls Aluminum Company Site, Flathead County, Montana	TDD No: 0004/1305-04
Photo No. 9	Date: 9/24/2013

Direction Photo Taken: S			
Description: Showing location for groundwater sample: CF-GW-MW-07.

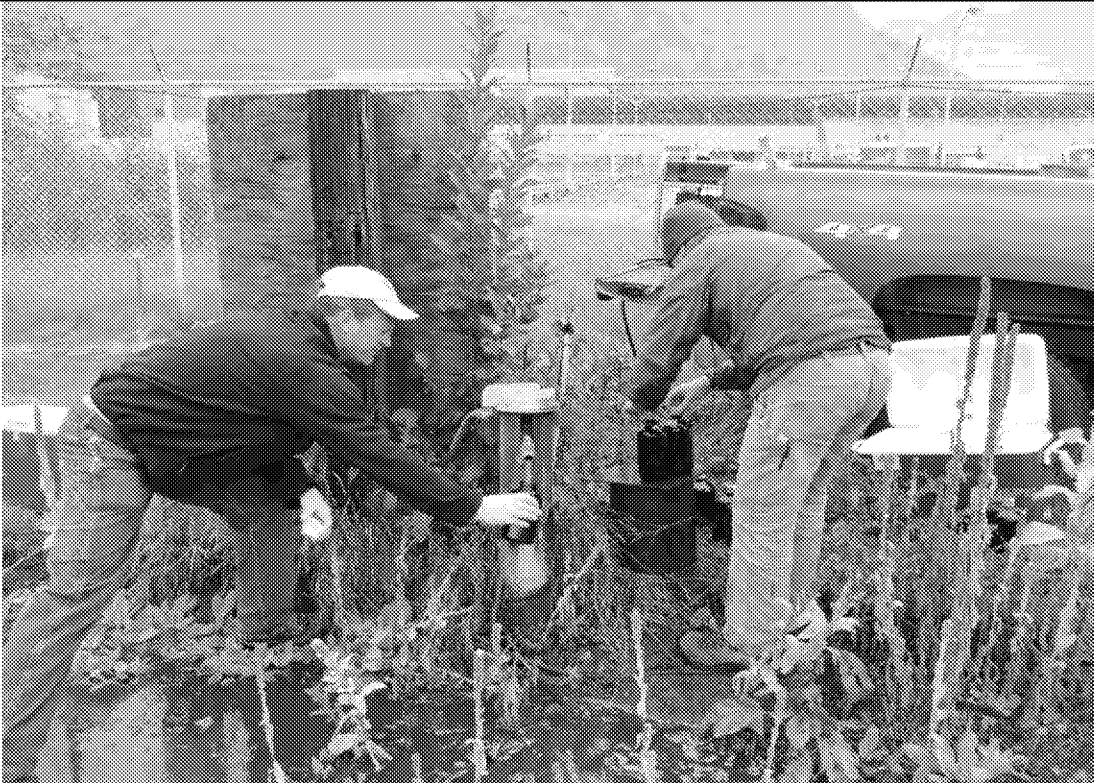
Project Name: Anaconda Aluminum Company		Site Location: Columbia Falls Aluminum Company Site, Flathead County, Montana	TDD No: 0004/1305-04
Photo No. 11	Date: 9/24/2013

Direction Photo Taken: E			
Description: Showing location for groundwater sample: CF-GW-MW-09. CFAC plant in background.

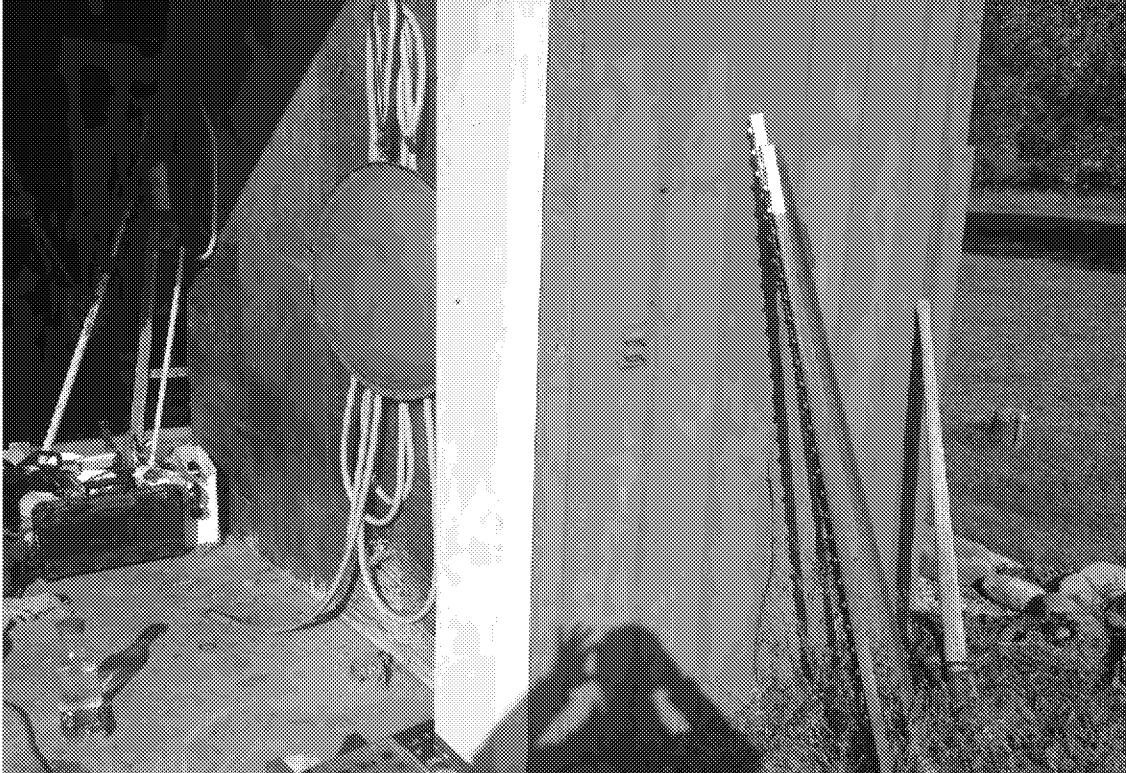
Project Name: Anaconda Aluminum Company		Site Location: Columbia Falls Aluminum Company Site, Flathead County, Montana	TDD No: 0004/1305-04
Photo No. 13	Date: 9/26/2013

Direction Photo Taken: SE			
Description: Showing location for groundwater sample: CF-GW-MW-12.

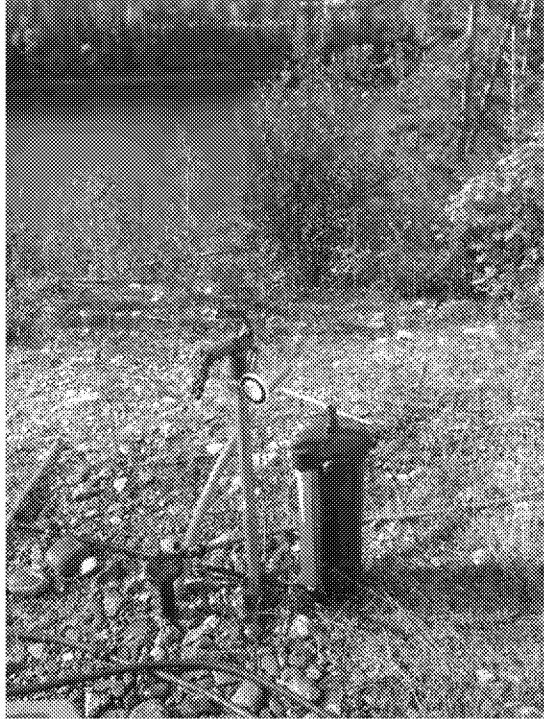
Project Name: Anaconda Aluminum Company		Site Location: Columbia Falls Aluminum Company Site, Flathead County, Montana	TDD No: 0004/1305-04
Photo No. 15	Date: 9/26/2013

Direction Photo Taken: E			
Description: Showing location for groundwater sample: CF-GW-MW-15.

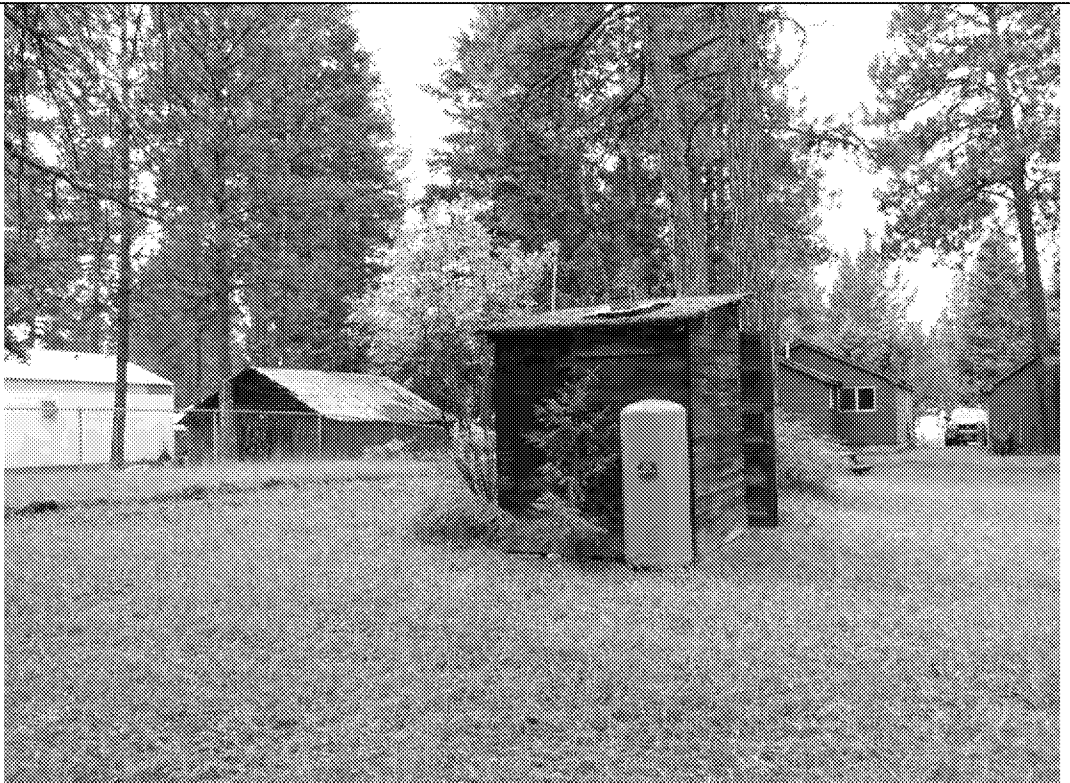
Photo No. 16	Date: 9/27/2013

Direction Photo Taken: SW		
Description: Showing location for groundwater sample: CF-GW-OP-02.

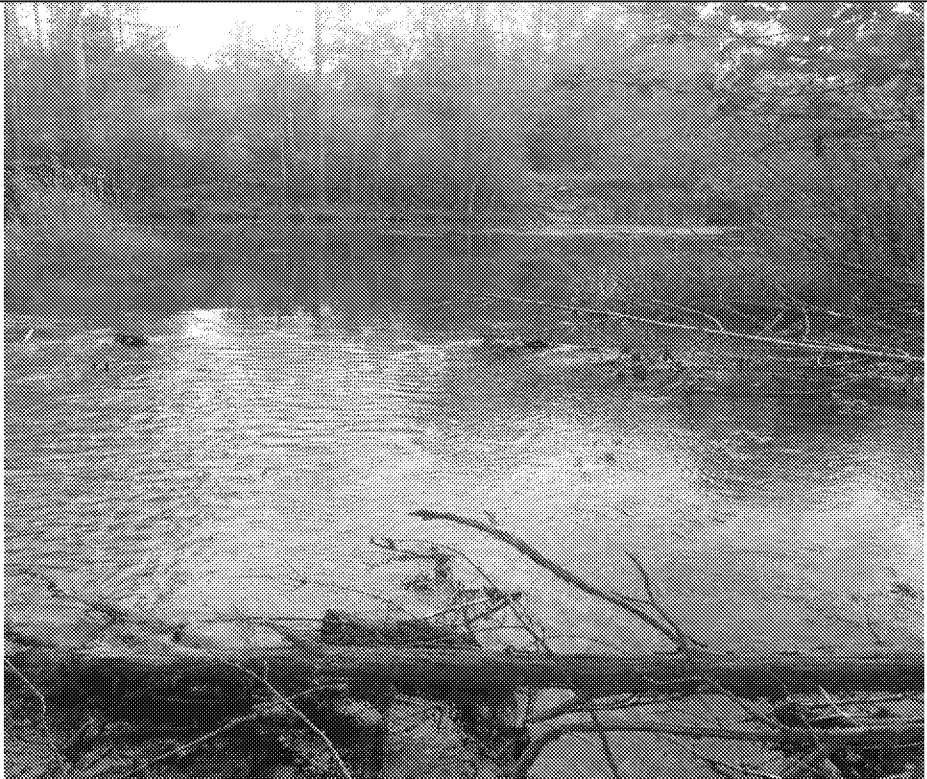
Project Name: Anaconda Aluminum Company		Site Location: Columbia Falls Aluminum Company Site, Flathead County, Montana	TDD No: 0004/1305-04
Photo No. 17	Date: 9/27/2013

Direction Photo Taken: W			
Description: Showing location for surface water sample: CF-SW-01.

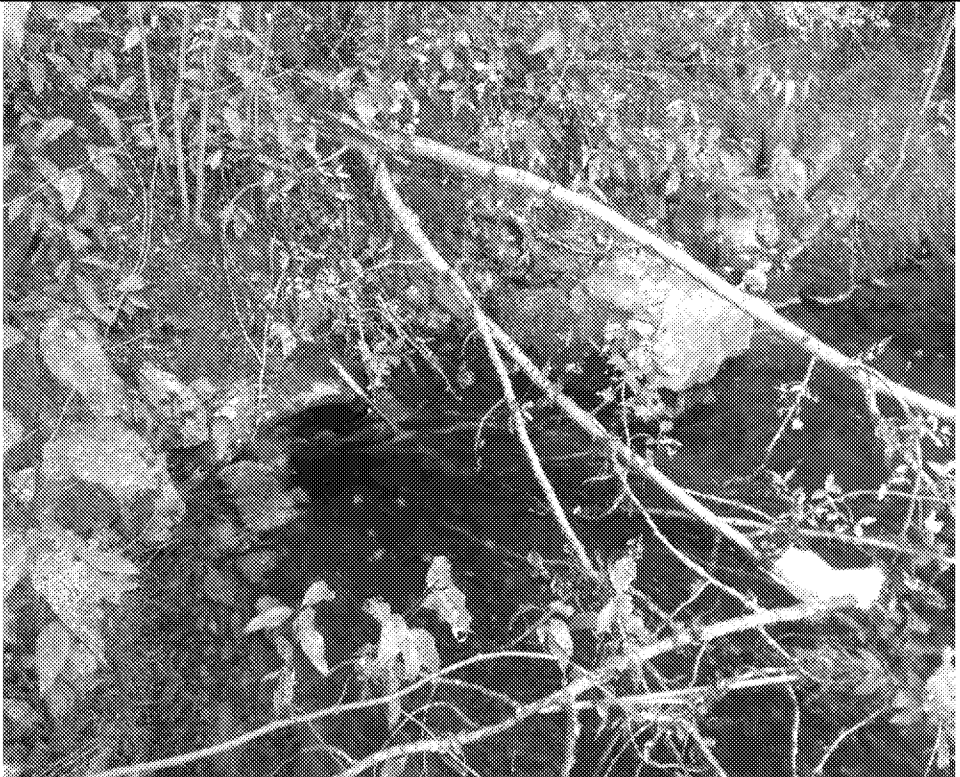
Photo No. 18	Date: 9/27/2013

Direction Photo Taken: S		
Description: Showing location for sediment sample: CF-SD-01.

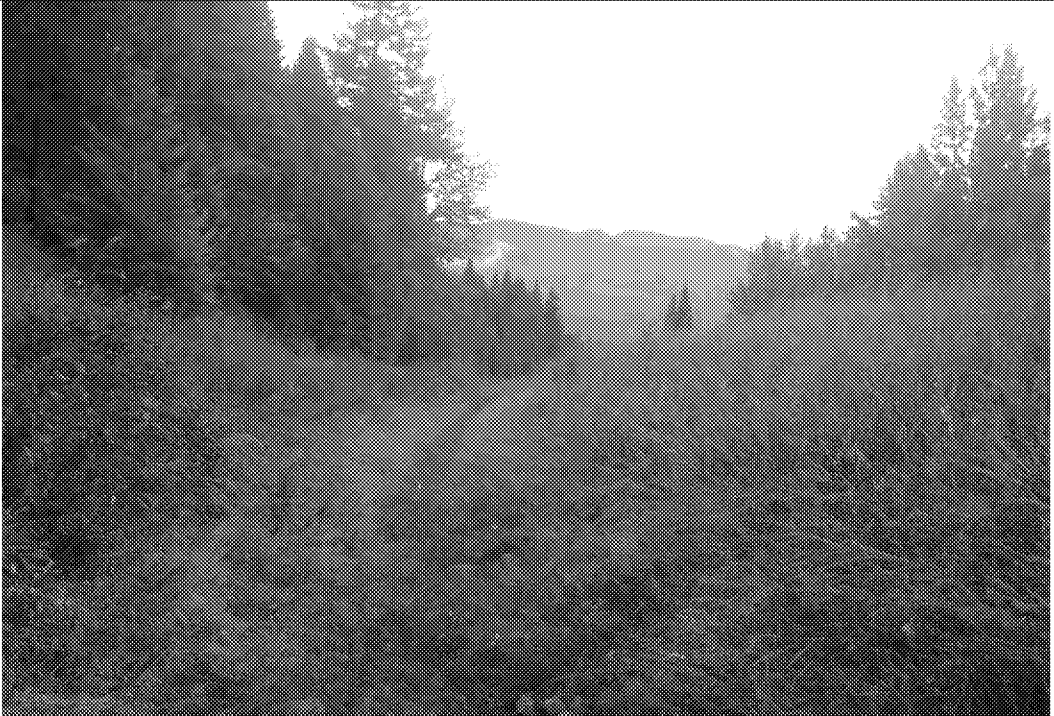
Project Name: Anaconda Aluminum Company		Site Location: Columbia Falls Aluminum Company Site, Flathead County, Montana	TDD No: 0004/1305-04
Photo No. 19	Date: 9/27/2013

Direction Photo Taken: SE			
Description: Showing location for sediment sample: CF-SD-02.

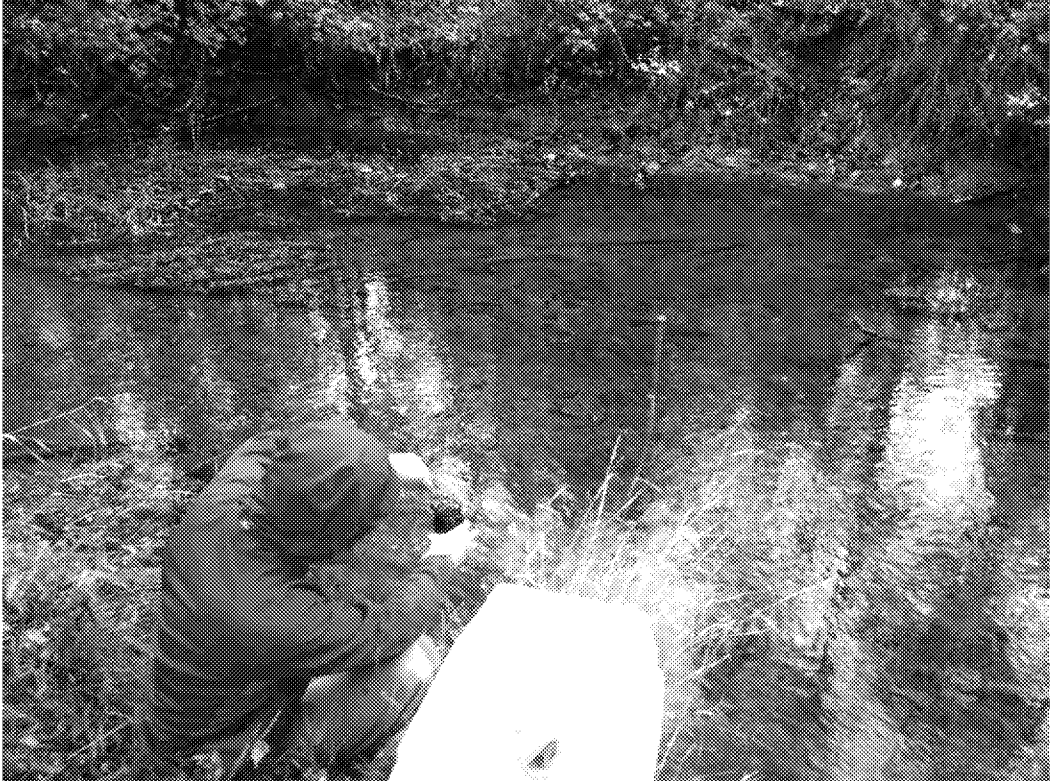
Project Name: Anaconda Aluminum Company		Site Location: Columbia Falls Aluminum Company Site, Flathead County, Montana	TDD No: 0004/1305-04
Photo No. 21	Date: 9/30/2013

Direction Photo Taken: N			
Description: Showing location for sediment sample: CF-SD-03.

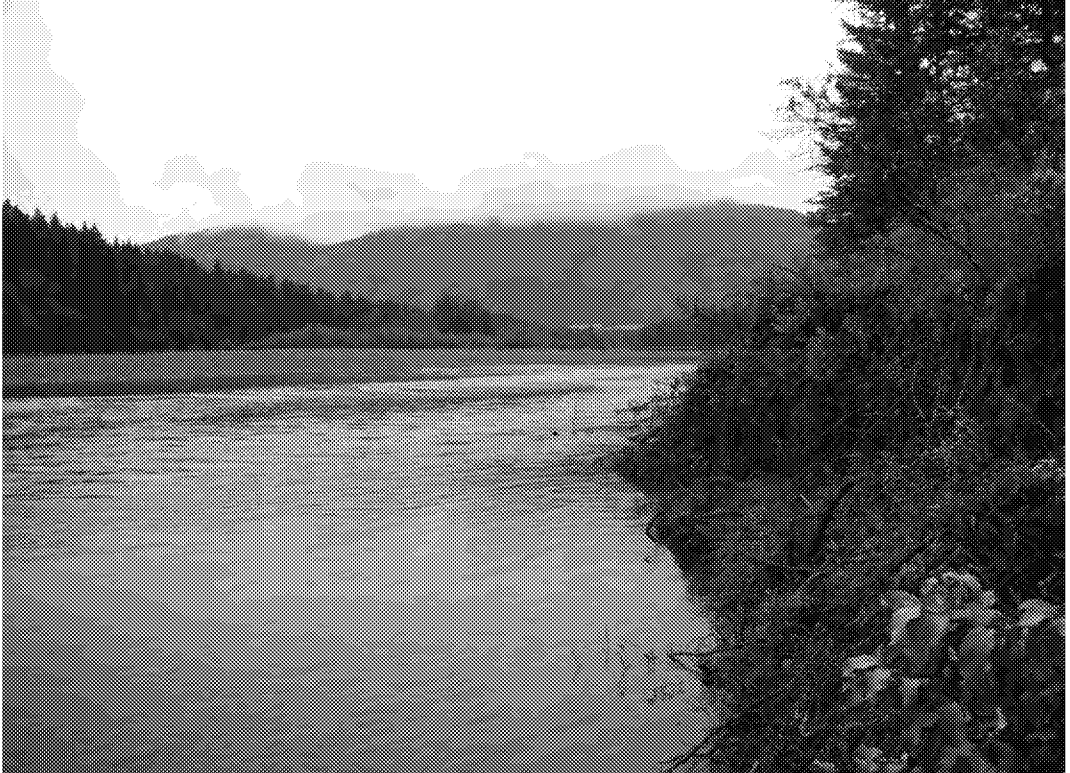
Project Name: Anaconda Aluminum Company		Site Location: Columbia Falls Aluminum Company Site, Flathead County, Montana	TDD No: 0004/1305-04
Photo No. 23	Date: 9/25/2013

Direction Photo Taken: N			
Description: Showing location for co-located sediment/surface water samples: CF-SD-05 / CF-SW-05.

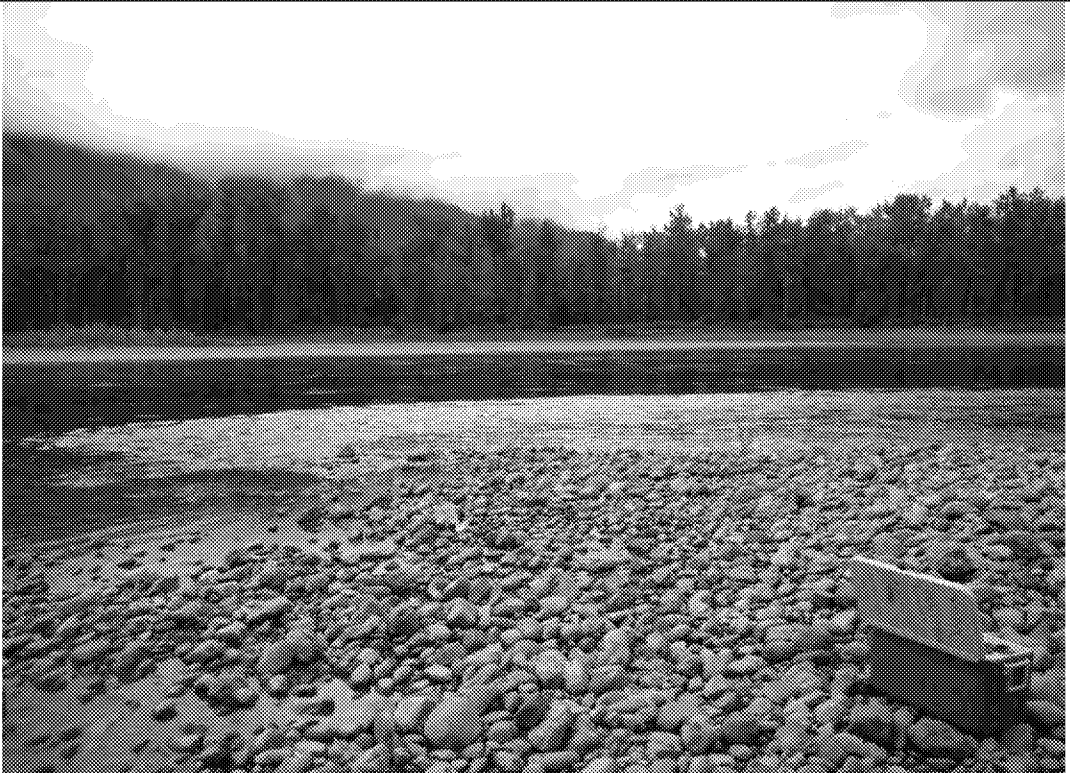
Photo No. 24	Date: 9/25/2013

Direction Photo Taken: SE		
Description: Showing location for co-located sediment/surface water samples: CF-SD-06 / CF-SW-06.

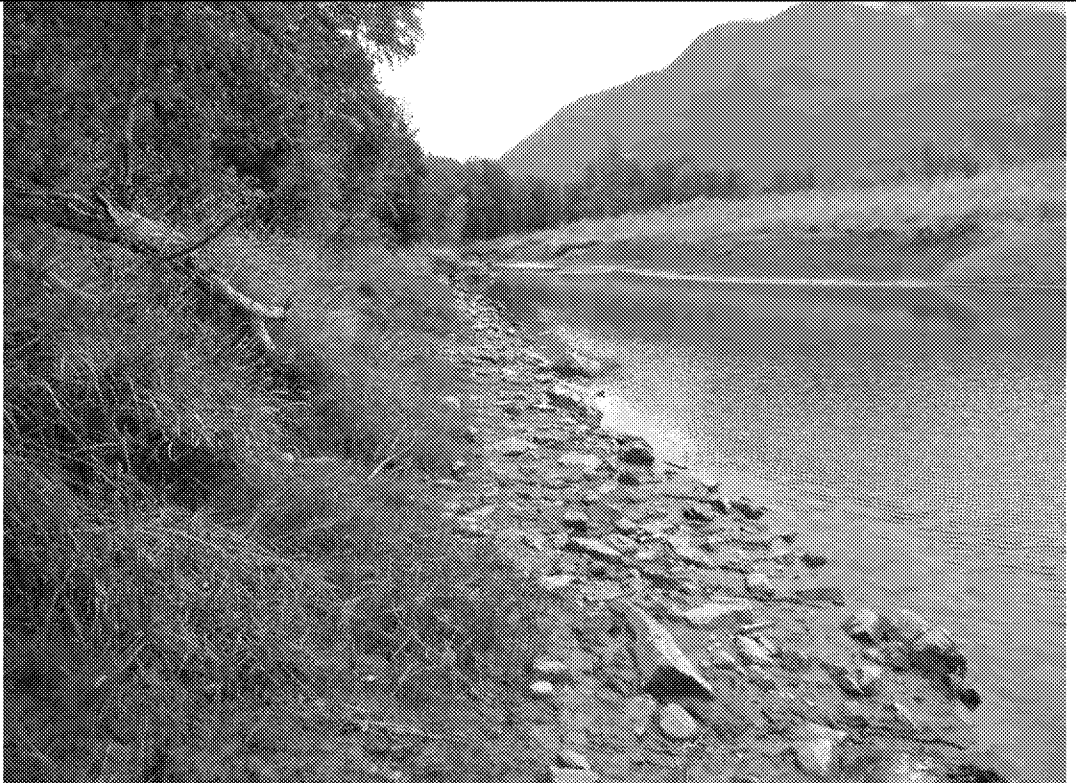
Project Name: Anaconda Aluminum Company		Site Location: Columbia Falls Aluminum Company Site, Flathead County, Montana	TDD No: 0004/1305-04
Photo No. 25	Date: 9/25/2013

Direction Photo Taken: E			
Description: Showing location for co-located sediment/surface water samples: CF-SD-07 / CF-SW-07.

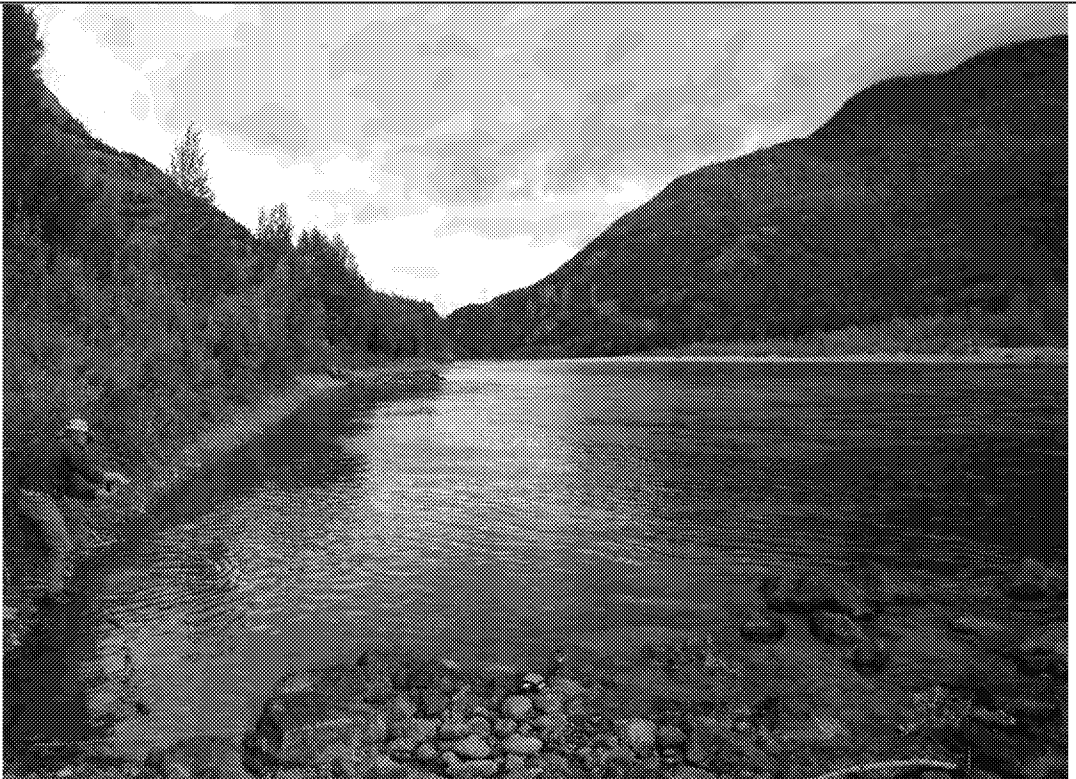
Photo No. 26	Date: 9/25/2013

Direction Photo Taken: E		
Description: Showing location for co-located sediment/surface water samples: CF-SD-08 / CF-SW-08.

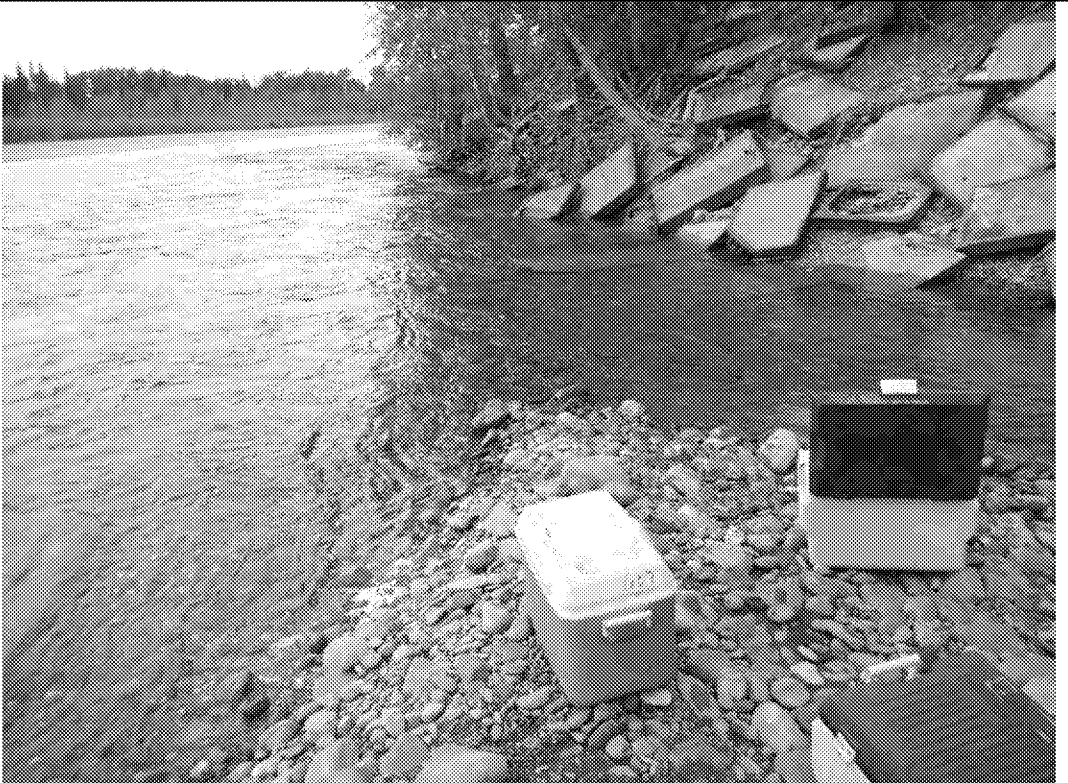
Project Name: Anaconda Aluminum Company		Site Location: Columbia Falls Aluminum Company Site, Flathead County, Montana	TDD No: 0004/1305-04
Photo No. 27	Date: 9/26/2013

Direction Photo Taken: W			
Description: Showing location for co-located sediment/surface water samples: CF-SD-09 / CF-SW-09. Cement potliner plant flooring on riverbank in background.

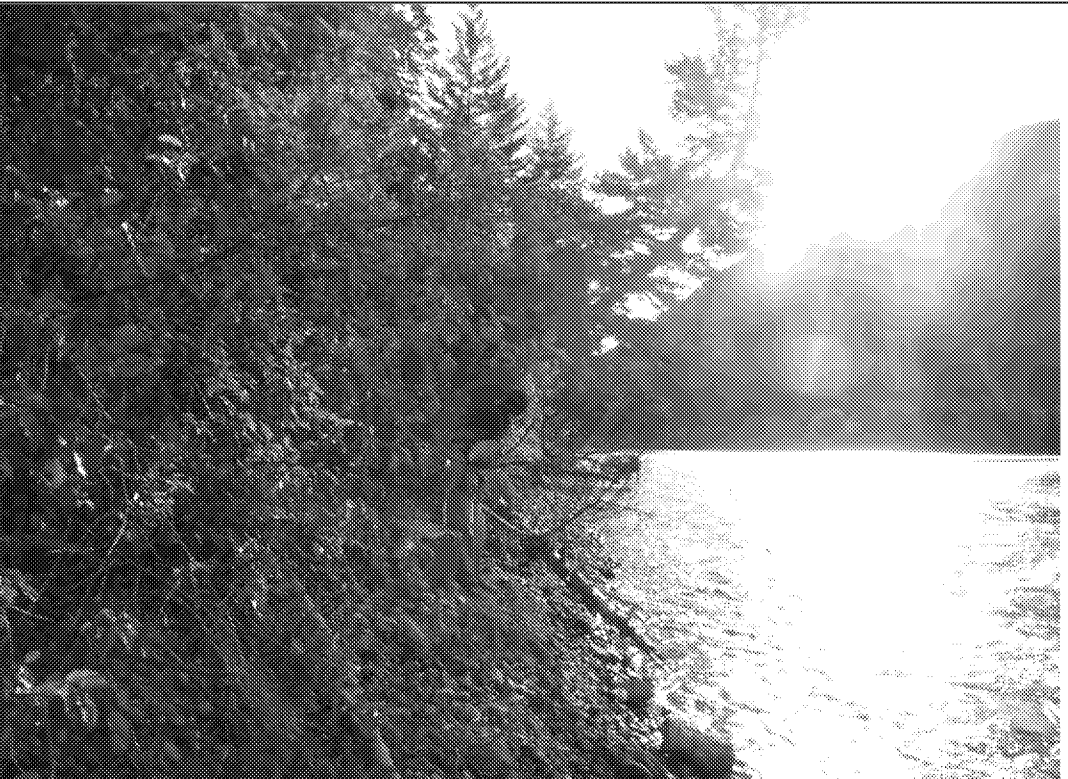
Photo No. 28	Date: 9/26/2013

Direction Photo Taken: E		
Description: Showing impassable river bank to sample location for co-located sediment/surface water samples: CF-SD-10 / CF-SW-10, CF-SD-11 / CF-SW-11, CF-SD-12 / CF-SW-12; Samples not collected.

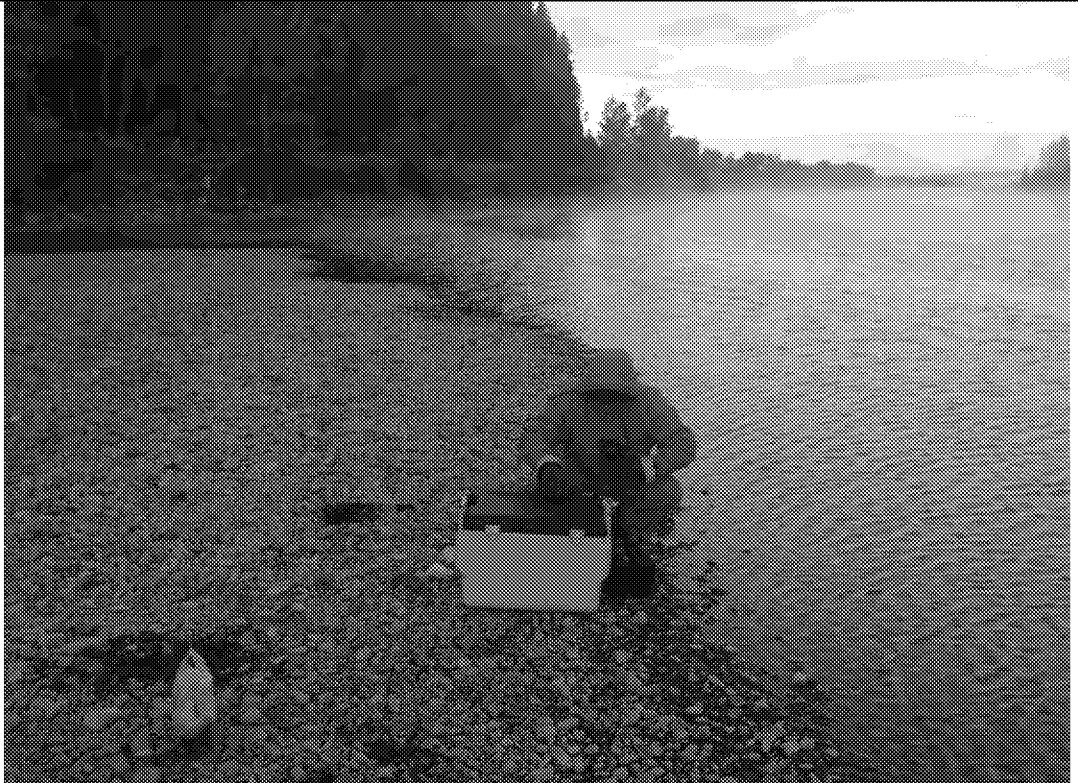
Project Name: Anaconda Aluminum Company		Site Location: Columbia Falls Aluminum Company Site, Flathead County, Montana	TDD No: 0004/1305-04
Photo No. 29	Date: 9/27/2013

Direction Photo Taken: SW			
Description: Showing location for co-located sediment/surface water samples: CF-SD-13 / CF-SW-13.

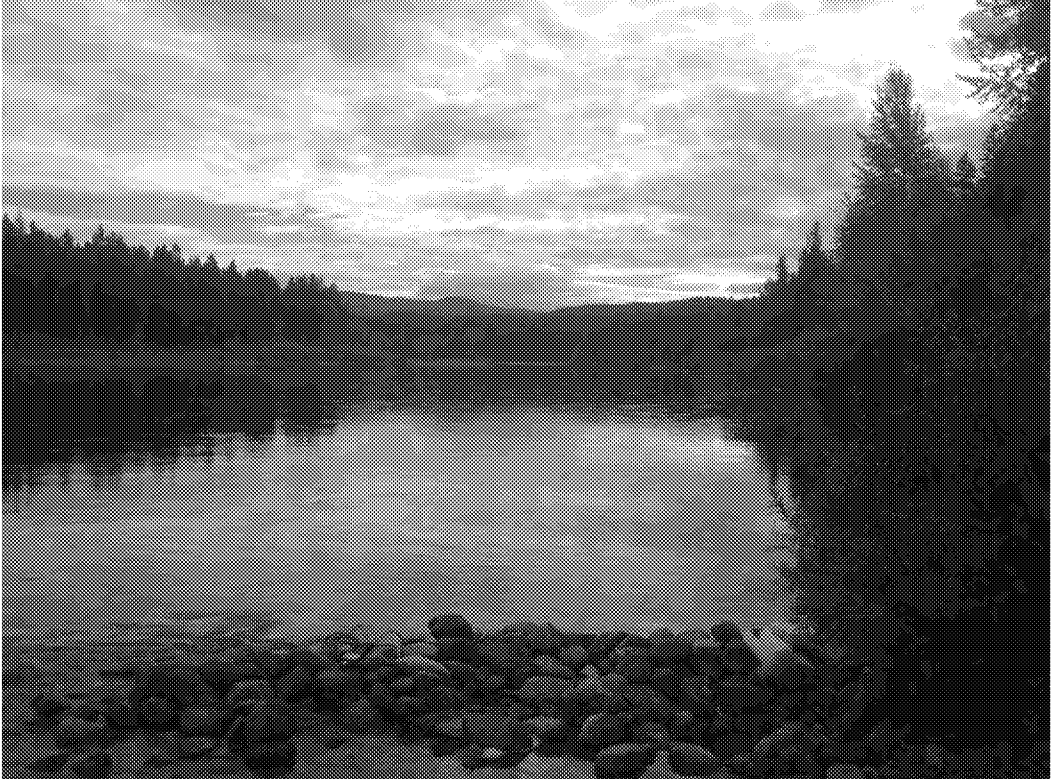
Project Name: Anaconda Aluminum Company		Site Location: Columbia Falls Aluminum Company Site, Flathead County, Montana	TDD No: 0004/1305-04
Photo No. 31	Date: 9/27/2013

Direction Photo Taken: SE			
Description: Showing location for co-located sediment/surface water samples: CF-SD-15 / CF-SW-15.

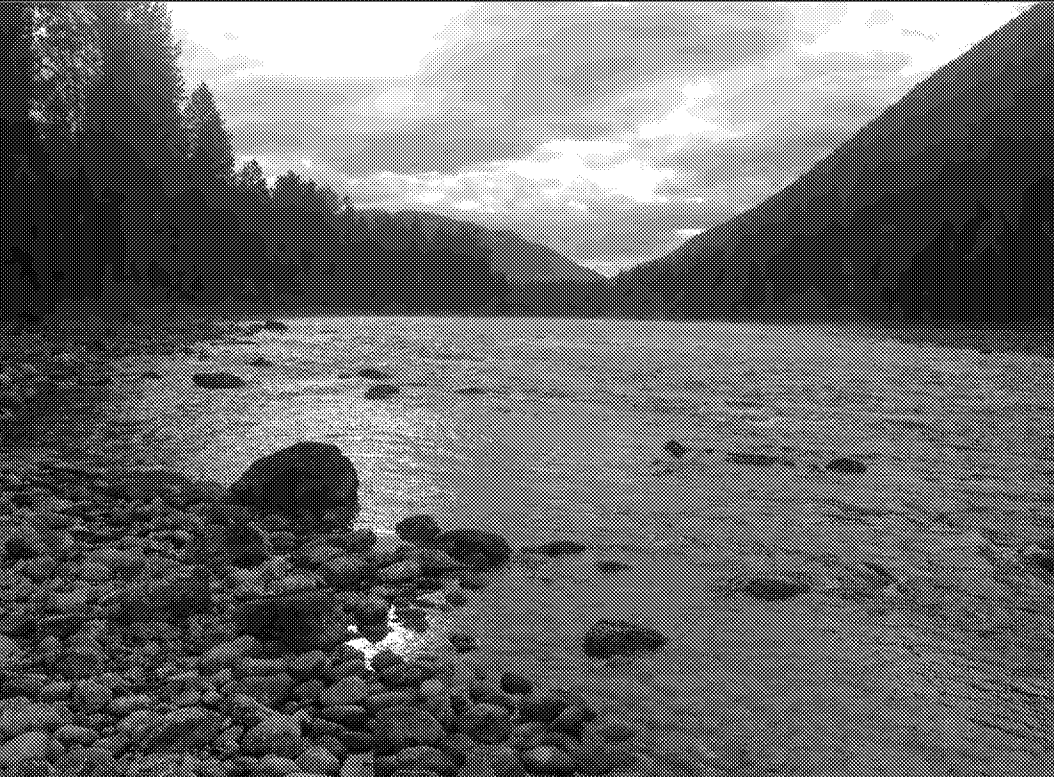
Photo No. 32	Date: 9/27/2013

Direction Photo Taken: SE		
Description: Showing location for co-located sediment/surface water samples: CF-SD-16 / CF-SW-16.

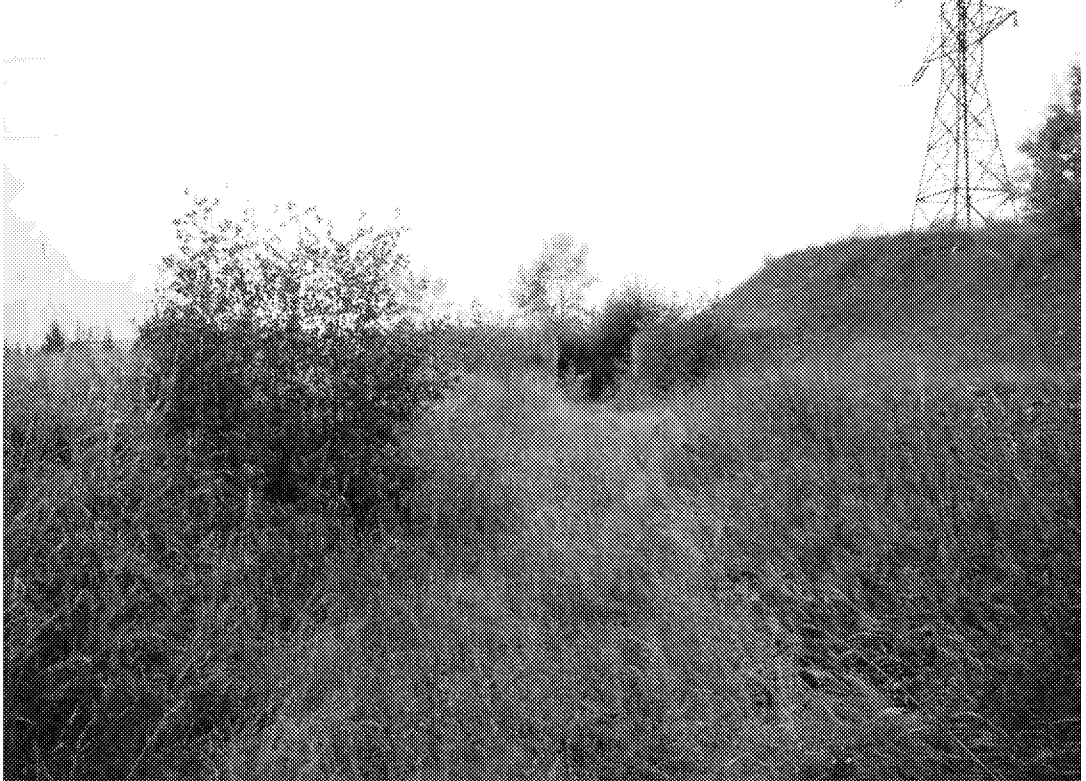
Project Name: Anaconda Aluminum Company		Site Location: Columbia Falls Aluminum Company Site, Flathead County, Montana	TDD No: 0004/1305-04
Photo No. 33	Date: 9/24/2013

Direction Photo Taken: W			
Description: Showing location for sediment sample: CF-SD-OP-01. Overflow gate in Cedar Creek Overflow Drainage Ditch in background.

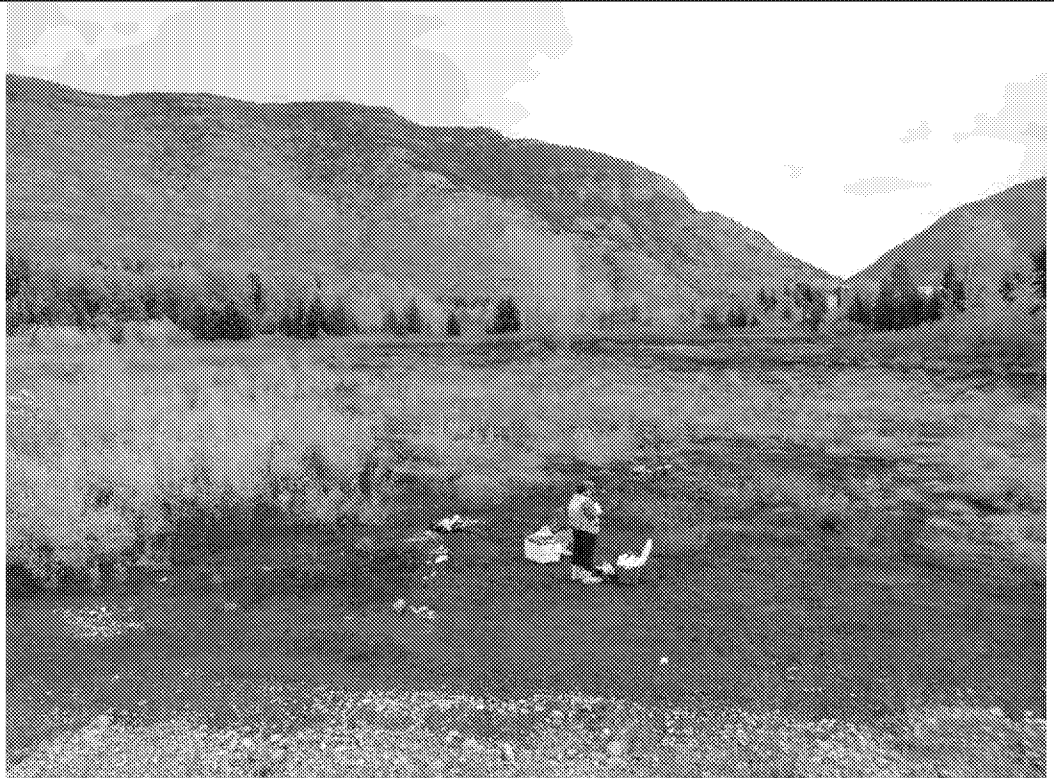
Photo No. 34	Date: 9/30/2013

Direction Photo Taken: E		
Description: Showing location for waste source sample: CF-WS-17.

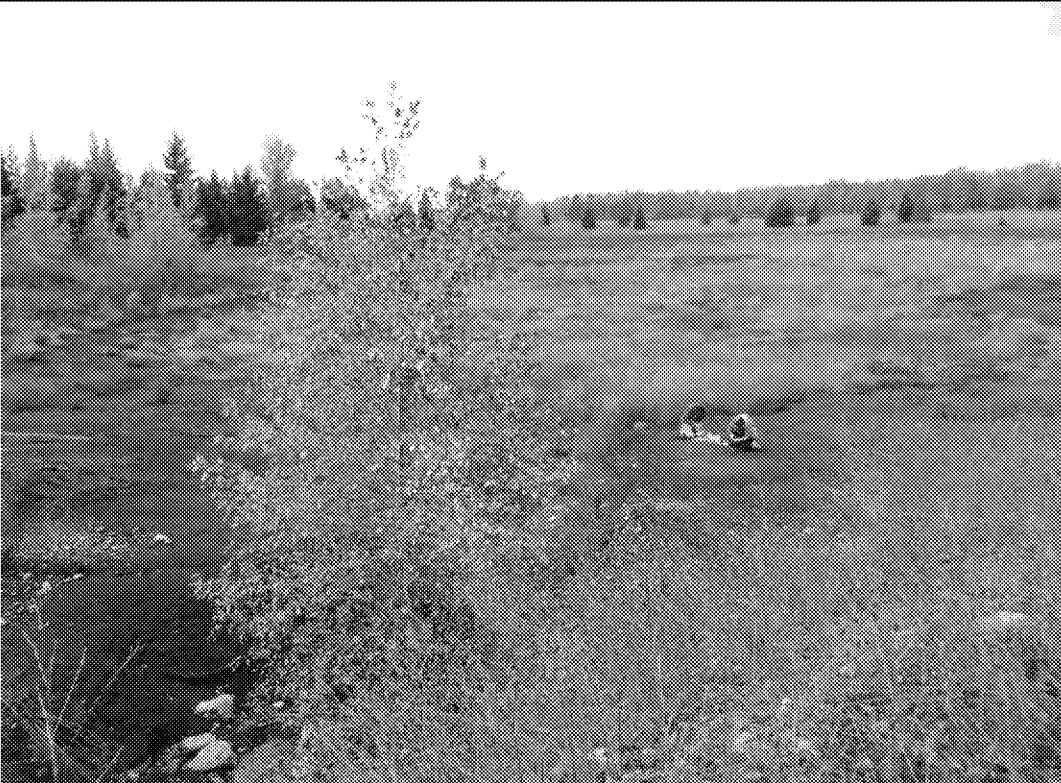
Project Name: Anaconda Aluminum Company		Site Location: Columbia Falls Aluminum Company Site, Flathead County, Montana	TDD No: 0004/1305-04
Photo No. 35	Date: 9/30/2013

Direction Photo Taken: W			
Description: Showing location for waste source sample: CF-WS-18.
